US-CE-C Property of the  
United States Government  
**The REMR Bulletin**

News from the Repair, Evaluation, Maintenance,  
and Rehabilitation Research Program

VOL 5, NO.1

## Spillway Rehabilitation at Grapevine Lake Fort Worth District

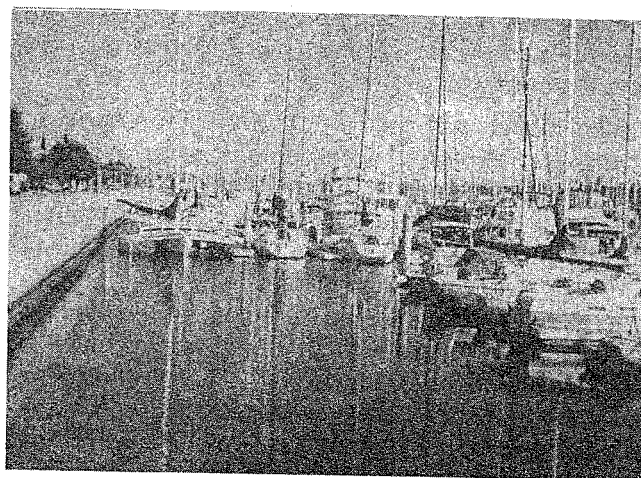
Figure 2. Marina Del Rey, Los Angeles County, California.

In February 1986, a 60-foot section of the concrete retaining wall at Marina Del Rey failed because corrosion had completely destroyed the reinforcing steel. The 9-foot-high wall, which was constructed in 60-foot sections, is 10 inches thick at the bottom and tapers to 7 inches at the top. The wall is approximately 8 miles long (Figure 2).
